Manhole Inspection Summary

Manhole # S13AA_016MH

Location Address: **REAR OF 2843 LAFAYETTE AVE** Cross Street: **POPLAR GROVE ST**

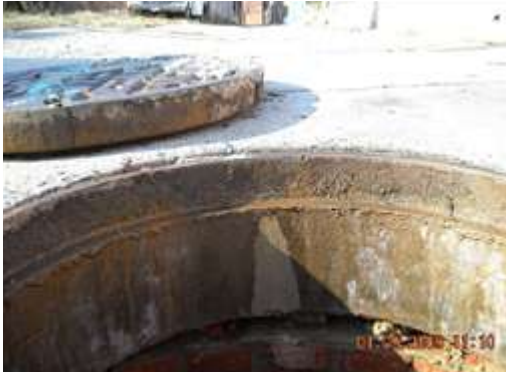
EVIDENCE OF INFLOW DUE TO
SHEETING

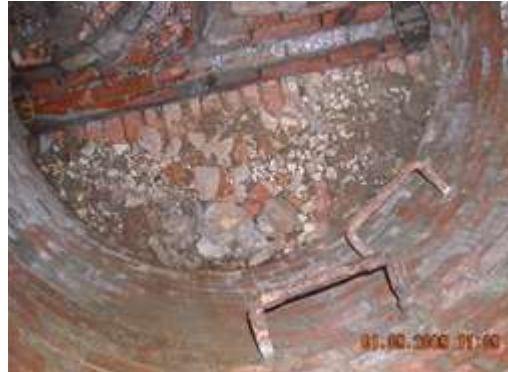
Defect 4

Condition: ☐ Sound ☐ Cracked ☐ Root Intrusion ☐ Deteriorated ☐ Leaks ☒ **Debris**

DEBRIS ON BENCH

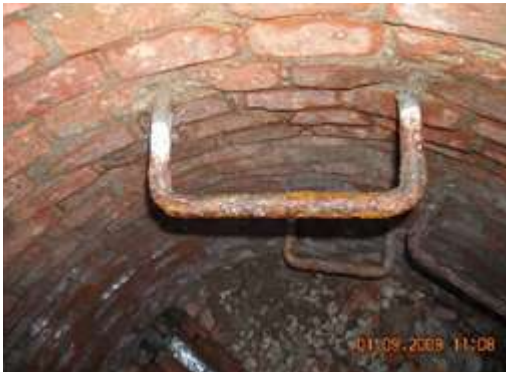
Defect 3

Steps Count: **3** Missing: **0** ☒ **Corroded**

STAIRS ARE SLIGHTLY CORRODED

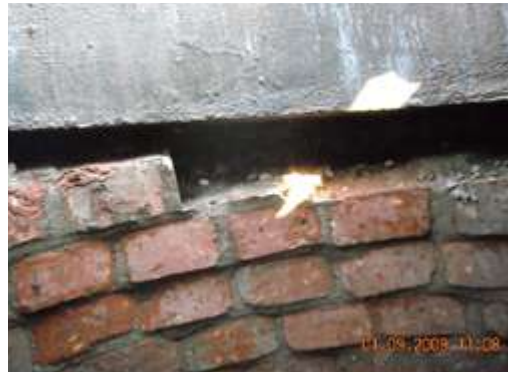
Defect 2

Condition: ☐ Sound ☐ Cracked ☐ Root Intrusion ☒ **Loose Brick** ☐ Deteriorated

MISSING BRICKS BELOW FRAME

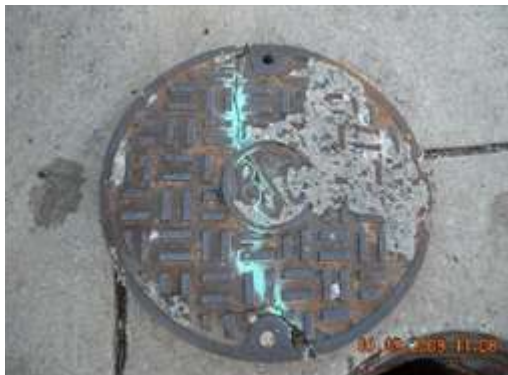
Defect 1

Type: **Sanitary** Condition: **Cracked** Cover Material: **Cast Iron**

CRACKED LID

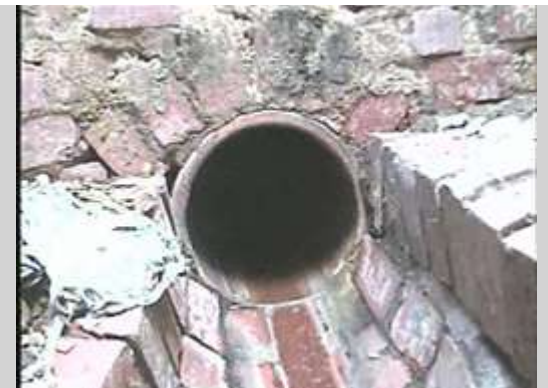
3 O'Clock Inflow

Pipe Height: **8.4** (in.) Rod and Bar (Angled)
Pipe Material: **Clay** ☐ Pipe Lined
Invert Depth: **6.90** (ft.) Flow Characteristics: **Slow**
Deposits: ☒ None ☐ Mud ☐ Sludge ☐ Debris ☐ Grease
Silt Depth: (in.) Deposits Extent:
Infiltration: **None** Pipe Seal Cond: **Cracked**
